Natural England Commissioned Report NECR184

# River Eye SSSI: Strategic Restoration Plan

Technical Report

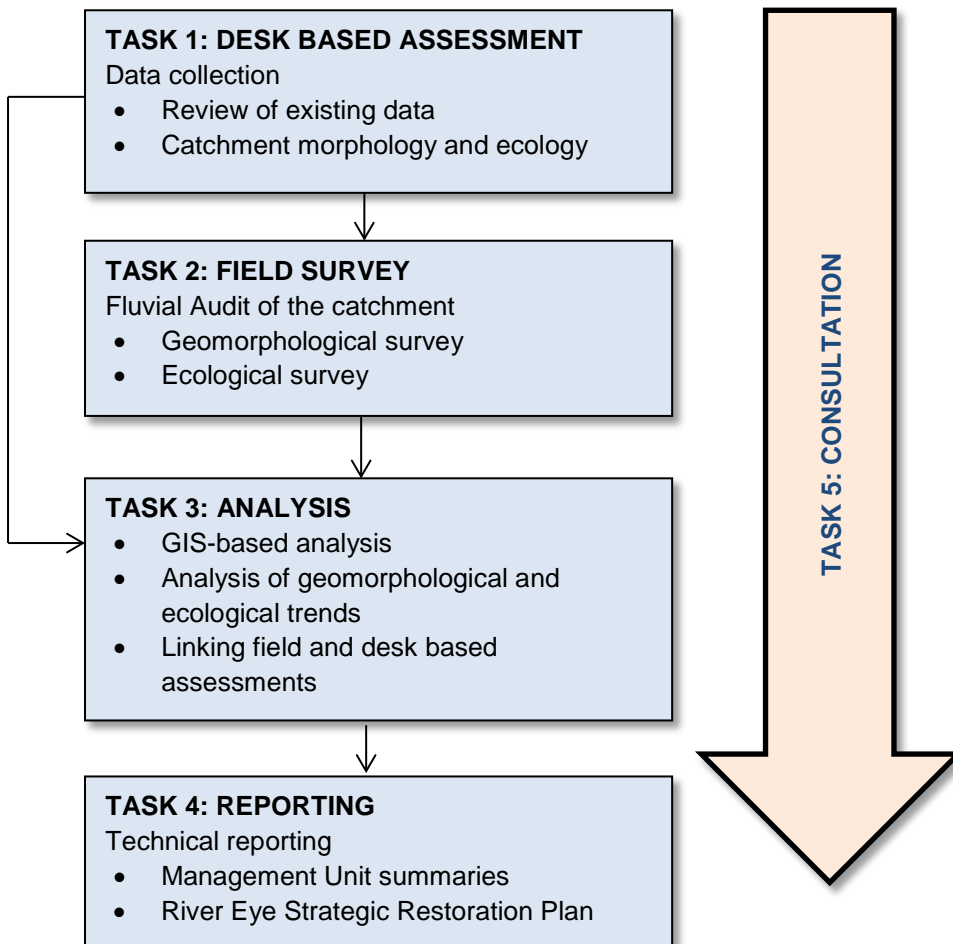
**Figure 3.1: Overview of the Fluvial Audit process**

The characterisation of the geomorphological behaviour of the River Eye has followed a standardised and well-established method of gathering relevant desk and field-based data, based on the principles of a Fluvial Audit. The River Eye fluvial audit comprises four main tasks, which are outlined in **Figure 3.1**. Details of the approach used to complete each task are provided in the subsequent sections. In addition, consultation with landowners and land managers is also undertaken as a parallel task alongside the fluvial audit. This is a crucial part of the strategic restoration planning process, and is used to provide additional information and inform the development of restoration options.

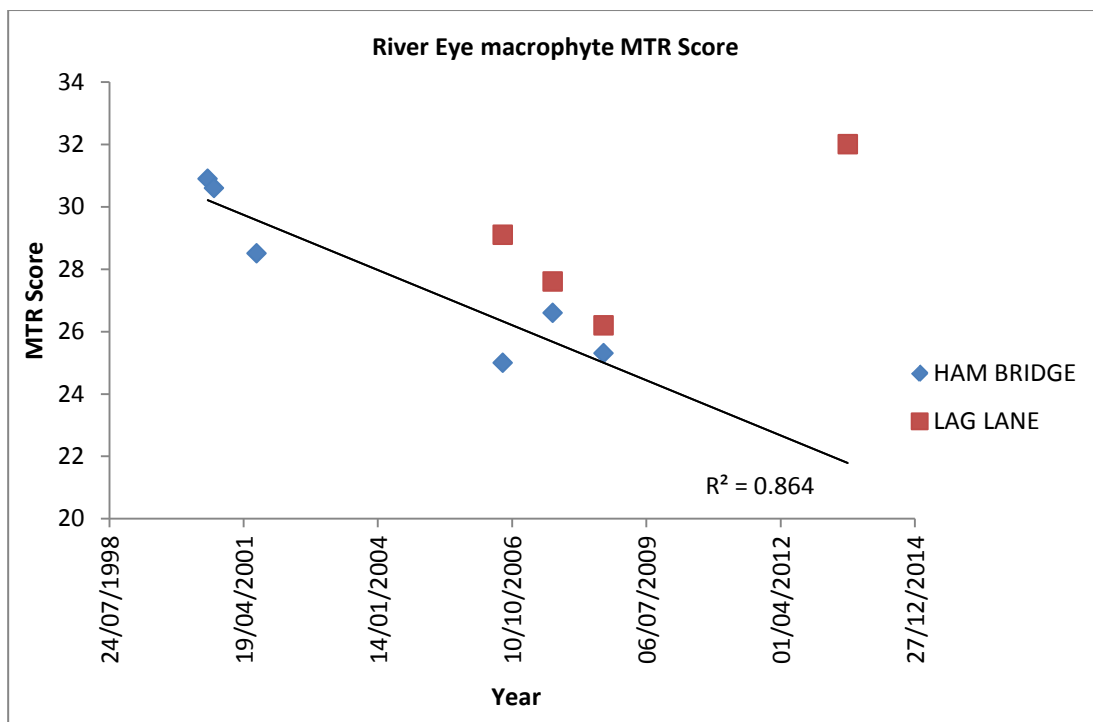
Figure 4.10: Macrophyte MTR score in the River Eye

These data indicate that the River Eye was becoming increasingly eutrophic over the period 2000-2008; however a recent survey (2013) has shown an increase in MTR score, inferring a decrease in eutrophy. This result suggests a decrease in nutrient input into the river, which correlates with **Figure 4.8**, where phosphate loading into the River Eye has decreased as a result of Catchment Sensitive Farming practices (Natural England, 2011). The data also show that macrophyte diversity has not significantly changed over time, indicating a relatively stable community. The data indicate that farming practices are likely to be a prevalent factor in the observed changes in macrophyte community.

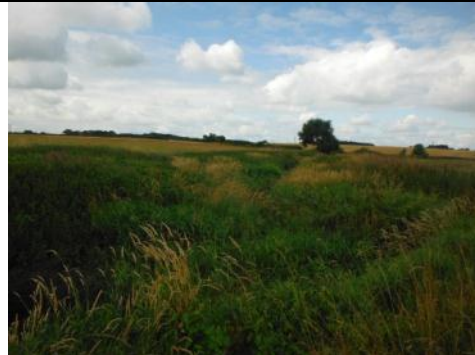
B: Channel choked by dense vegetation growth

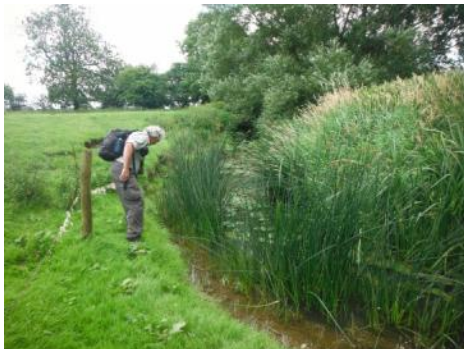
C: Evidence of natural channel adjustment

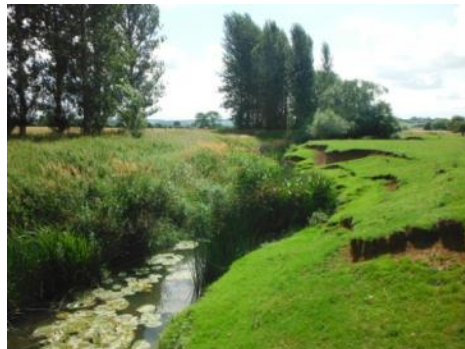
D: Historic bank slumping

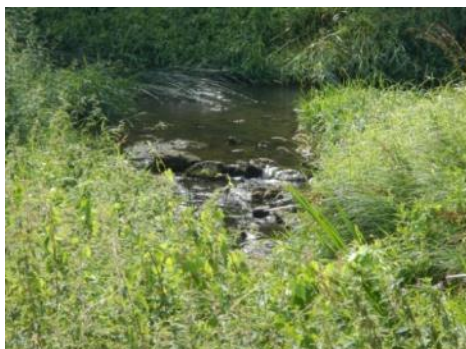
C: Riffle with exposed coarse bed material

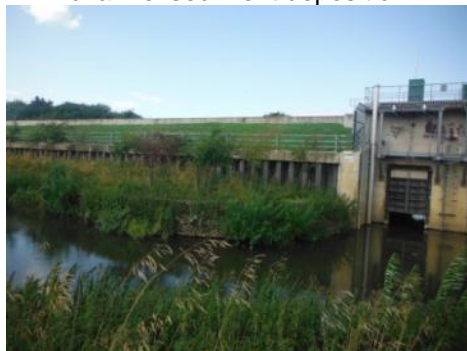
C: Impoundment due to sluices

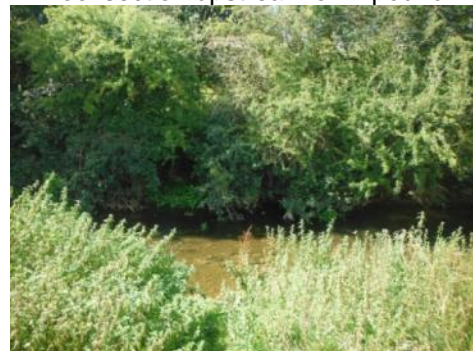
D: Riffle and adjacent toe scour

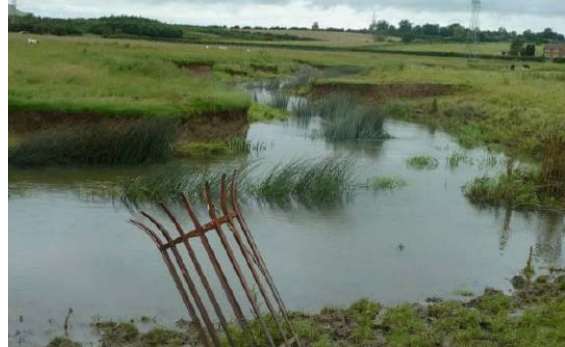
B: Active reach with bank erosion (JBA, 2013)

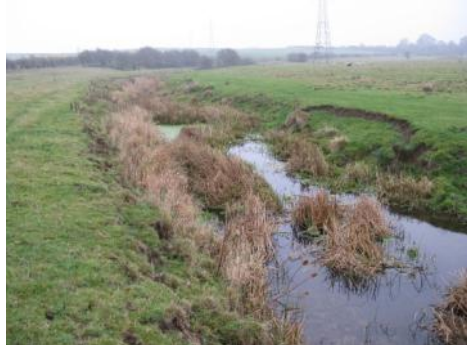
C: Collapsing bank and naturalising riparian margin

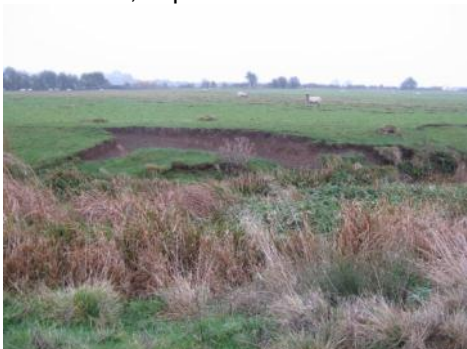
C: Bank collapse

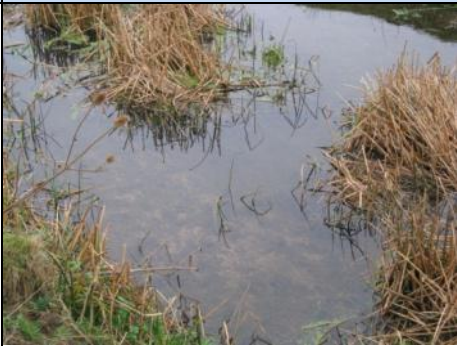
<p>A uniform part of MU8 where slow flows have encouraged fine sedimentation on the river bed.</p>	<ul style="list-style-type: none"> <li>• High turbidity in the water column limiting light penetration for macrophytes</li> <li>• Fine sedimentation on the channel bed limiting habitats for macrophyte communities, invertebrates and fish</li> </ul>	✓	✓	-	✓	-	✓	✓	✓
Channelisation and disconnection from the floodplain

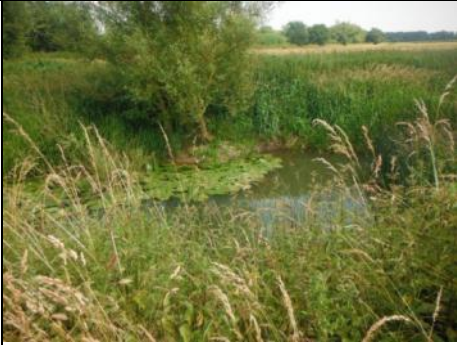
<p>Steep sided bank in MU1 which has resulted in reduced floodplain connectivity and low energy flows.</p>	<ul style="list-style-type: none"> <li>• Floodplain disconnection, limiting the development of riparian and wetland habitats for bird populations</li> <li>• Exacerbation of fine sedimentation issues</li> <li>• Lack of marginal habitats for colonisation by aquatic vegetation</li> <li>• Lack of morphological and flow diversity, limiting the range of habitats for fish and invertebrate communities</li> <li>• Higher energy flows contained within channel, increasing risk of erosion and bank failure</li> </ul>	✓	-	✓	✓	✓	✓	✓	✓

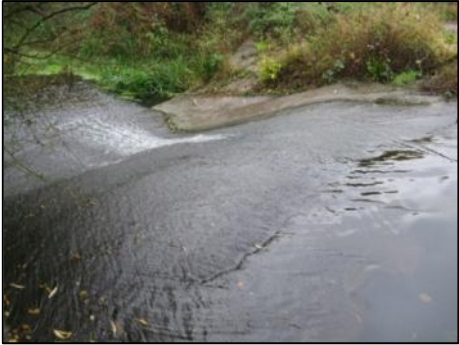
<p>An example of a weir that forms part of the weir complex at the downstream extent of the River Eye SSSI.</p>	<ul style="list-style-type: none"> <li>• Creation of impounded conditions</li> <li>• Exacerbation of fine sedimentation issues</li> <li>• Potential disruption of coarse sediment transport</li> <li>• Physical barrier to free movement of fish and other aquatic organisms</li> <li>• Lack of flow diversity, and reduced ability to tolerate flow variations</li> </ul>	-	-	-	-	-	✓	-	✓
Lack of suitable riparian habitats

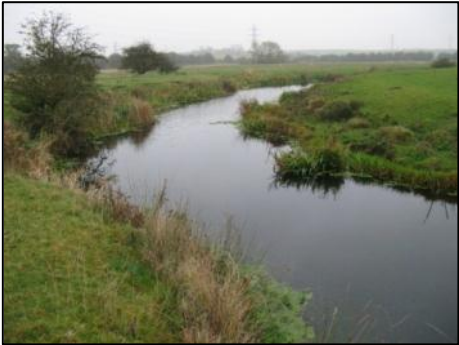
<p>An example of a reach with a lack of suitable riparian and marginal habitats in M.</p>	<ul style="list-style-type: none"> <li>• Limited in-channel shelter for fish populations and invertebrates</li> <li>• Limited riparian shelter for bird communities and mammals</li> </ul>	✓	✓	-	-	-	-	✓	✓
