**Leicestershire County Council:
North and East Melton
Mowbray Distributor Road
(MMDR)**

Stage 1 Road Safety Audit

Job No: 60542201.M001.RSA Reference: 60542201/M001/RSA/RSA1/02 Date Created: 21st December 2018

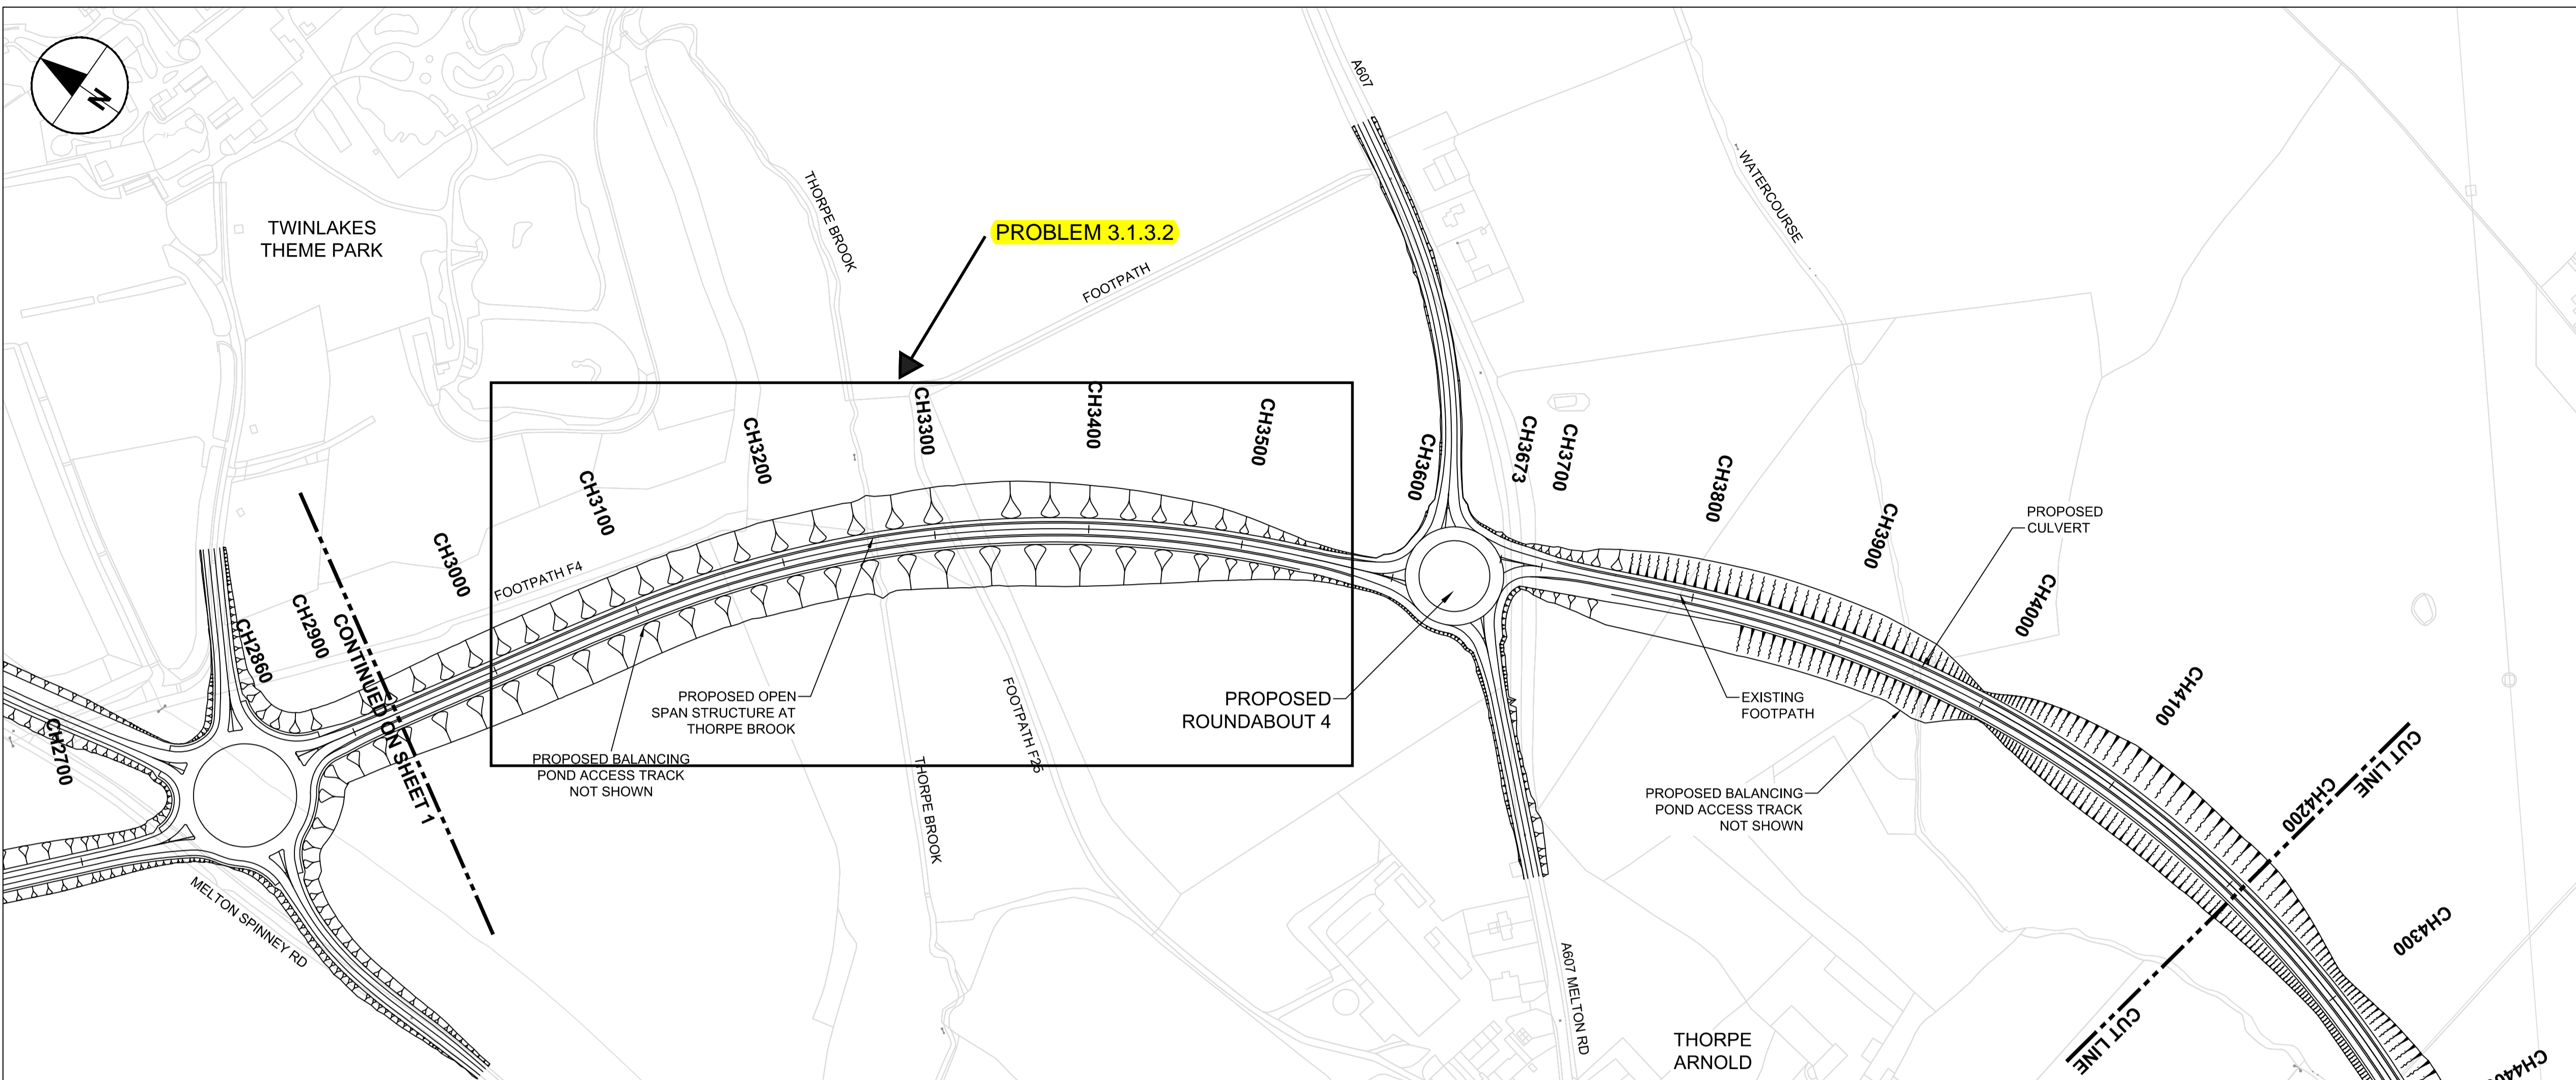
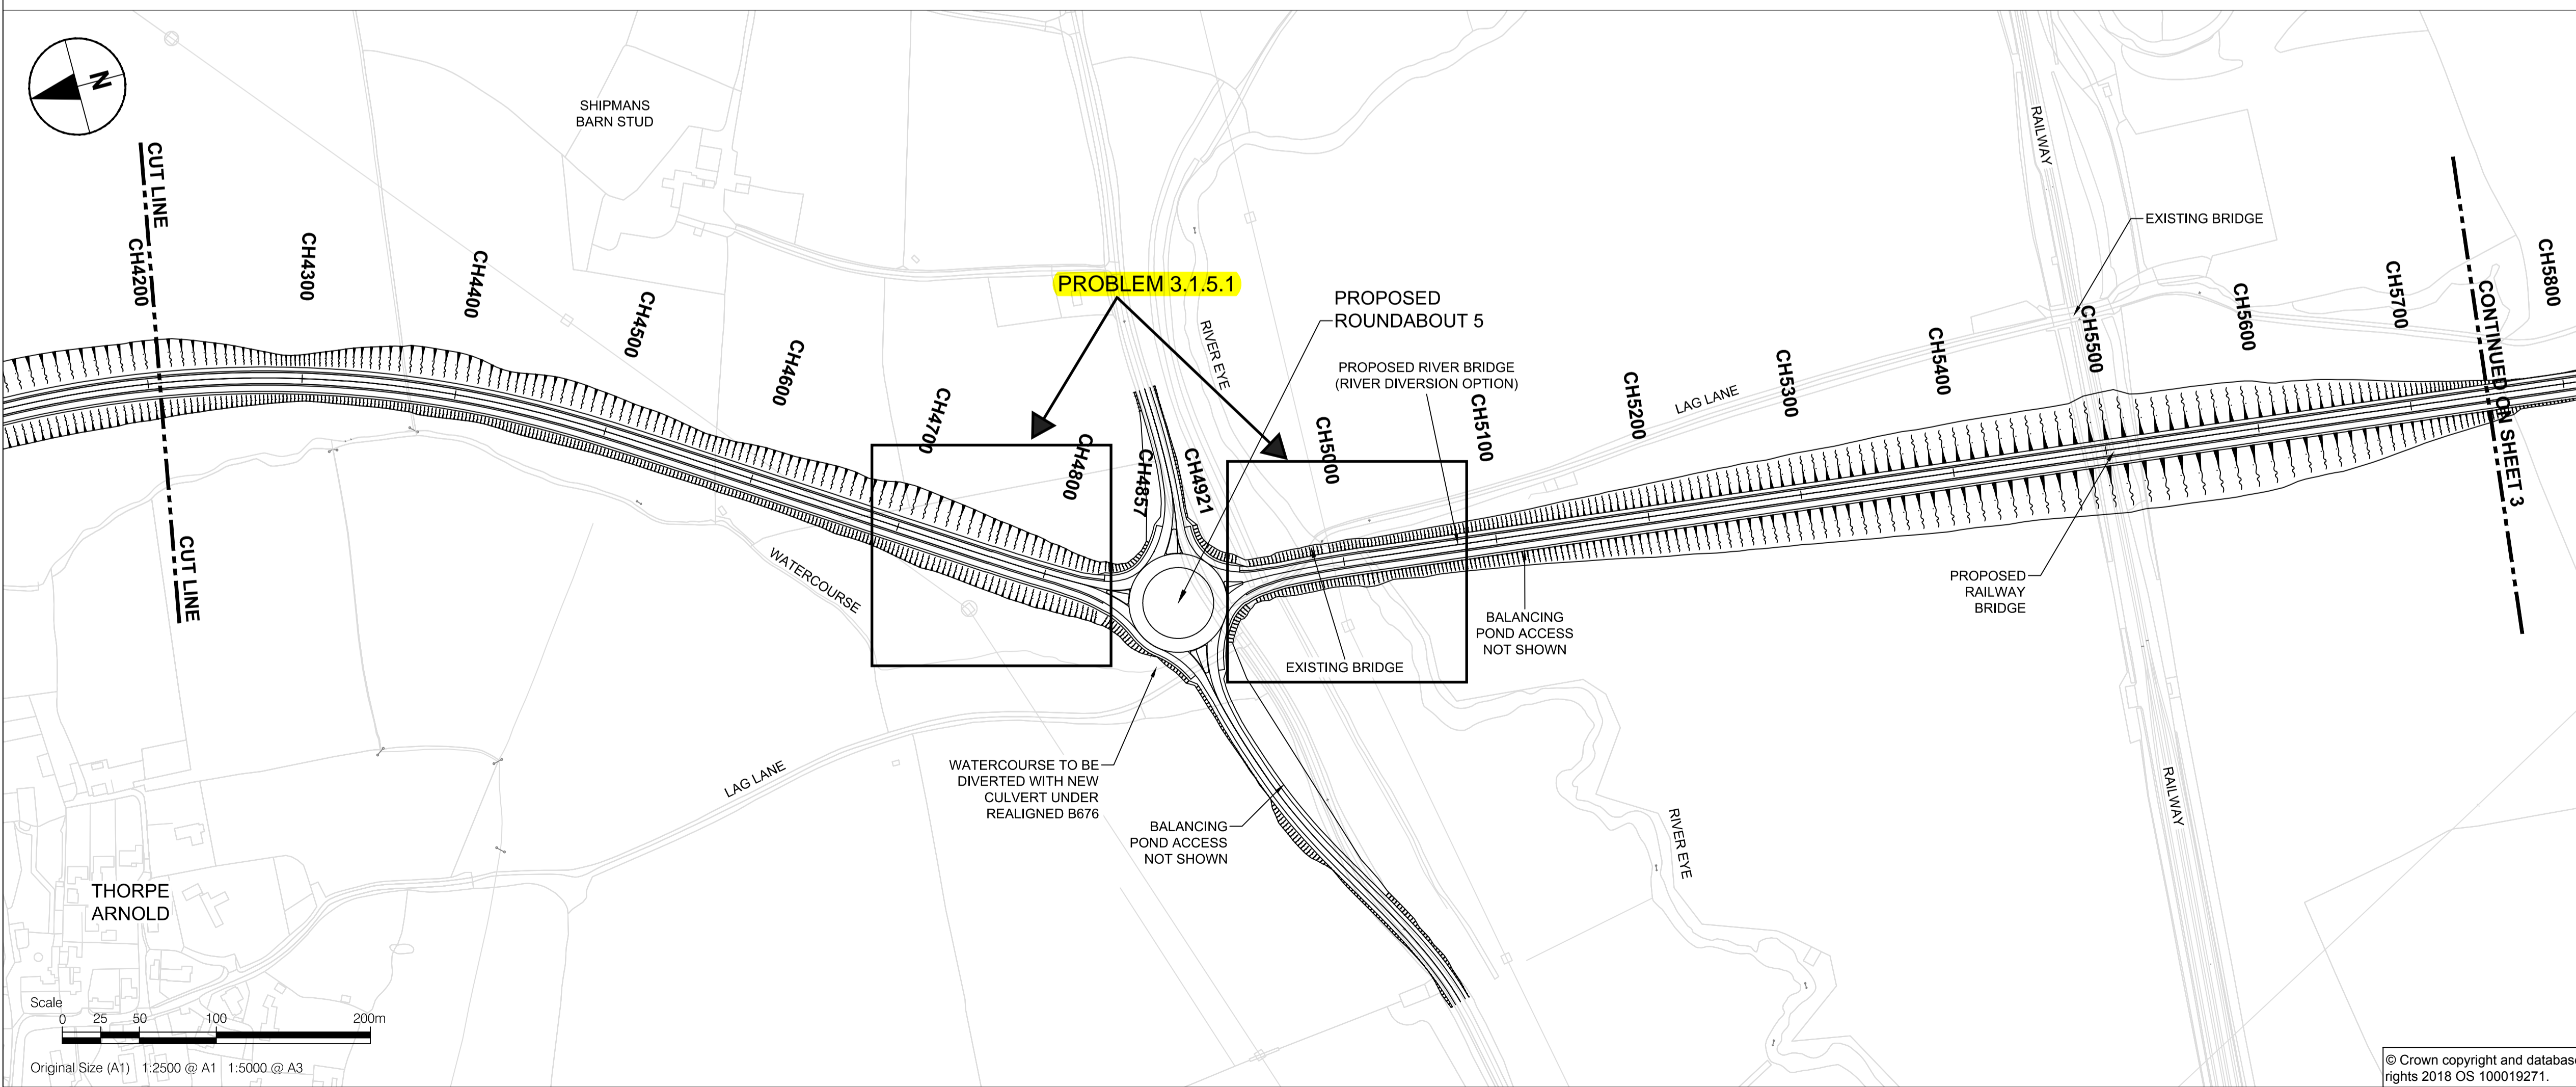
SHEET TITLE ROUTE PLAN SHEET 2 OF 3

Summary: Proposed speed limit between roundabouts may lead to late braking and shunt type collisions occurring due to short section of carriageway.

There is a proposed 60mph speed limit between roundabout 3 and roundabout 4 which is approximately 700m in length; prior to roundabout 3, the speed limit along the MMDR is 40mph. There are concerns that due to this relatively short section of carriageway and the fact there are two proposed balancing pond accesses between roundabout 3 and roundabout 4, the change in speed limit may lead to shunt type collisions with vehicles approaching the roundabouts too quickly or leaving the MMDR to access the balancing pond access tracks.

Summary: Insufficient Polished Stone Value (PSV) potentially leading to vehicles failing to stop efficiently as they approach the roundabout.

The northbound and southbound approaches to roundabout 5 consist of a straight section of downhill carriageway with a relatively steep gradient. At this stage of the design, no pavement details have been provided to the Audit Team; however, there are concerns that high vehicular approach speeds, along with the carriageway alignment, may lead to late braking resulting in shunt type collisions, or loss of control and/or overshoot collisions as vehicles approach the roundabout too quickly.

It is recommended that a review of the 60mph speed limit between roundabouts 3 and 4 is undertaken and consideration to reducing the speed limit to 40mph is considered at detail design.

It is recommended that a PSV of 68+ or High Friction Surfacing (HFS) is installed on the northbound and southbound approaches to roundabout 5.

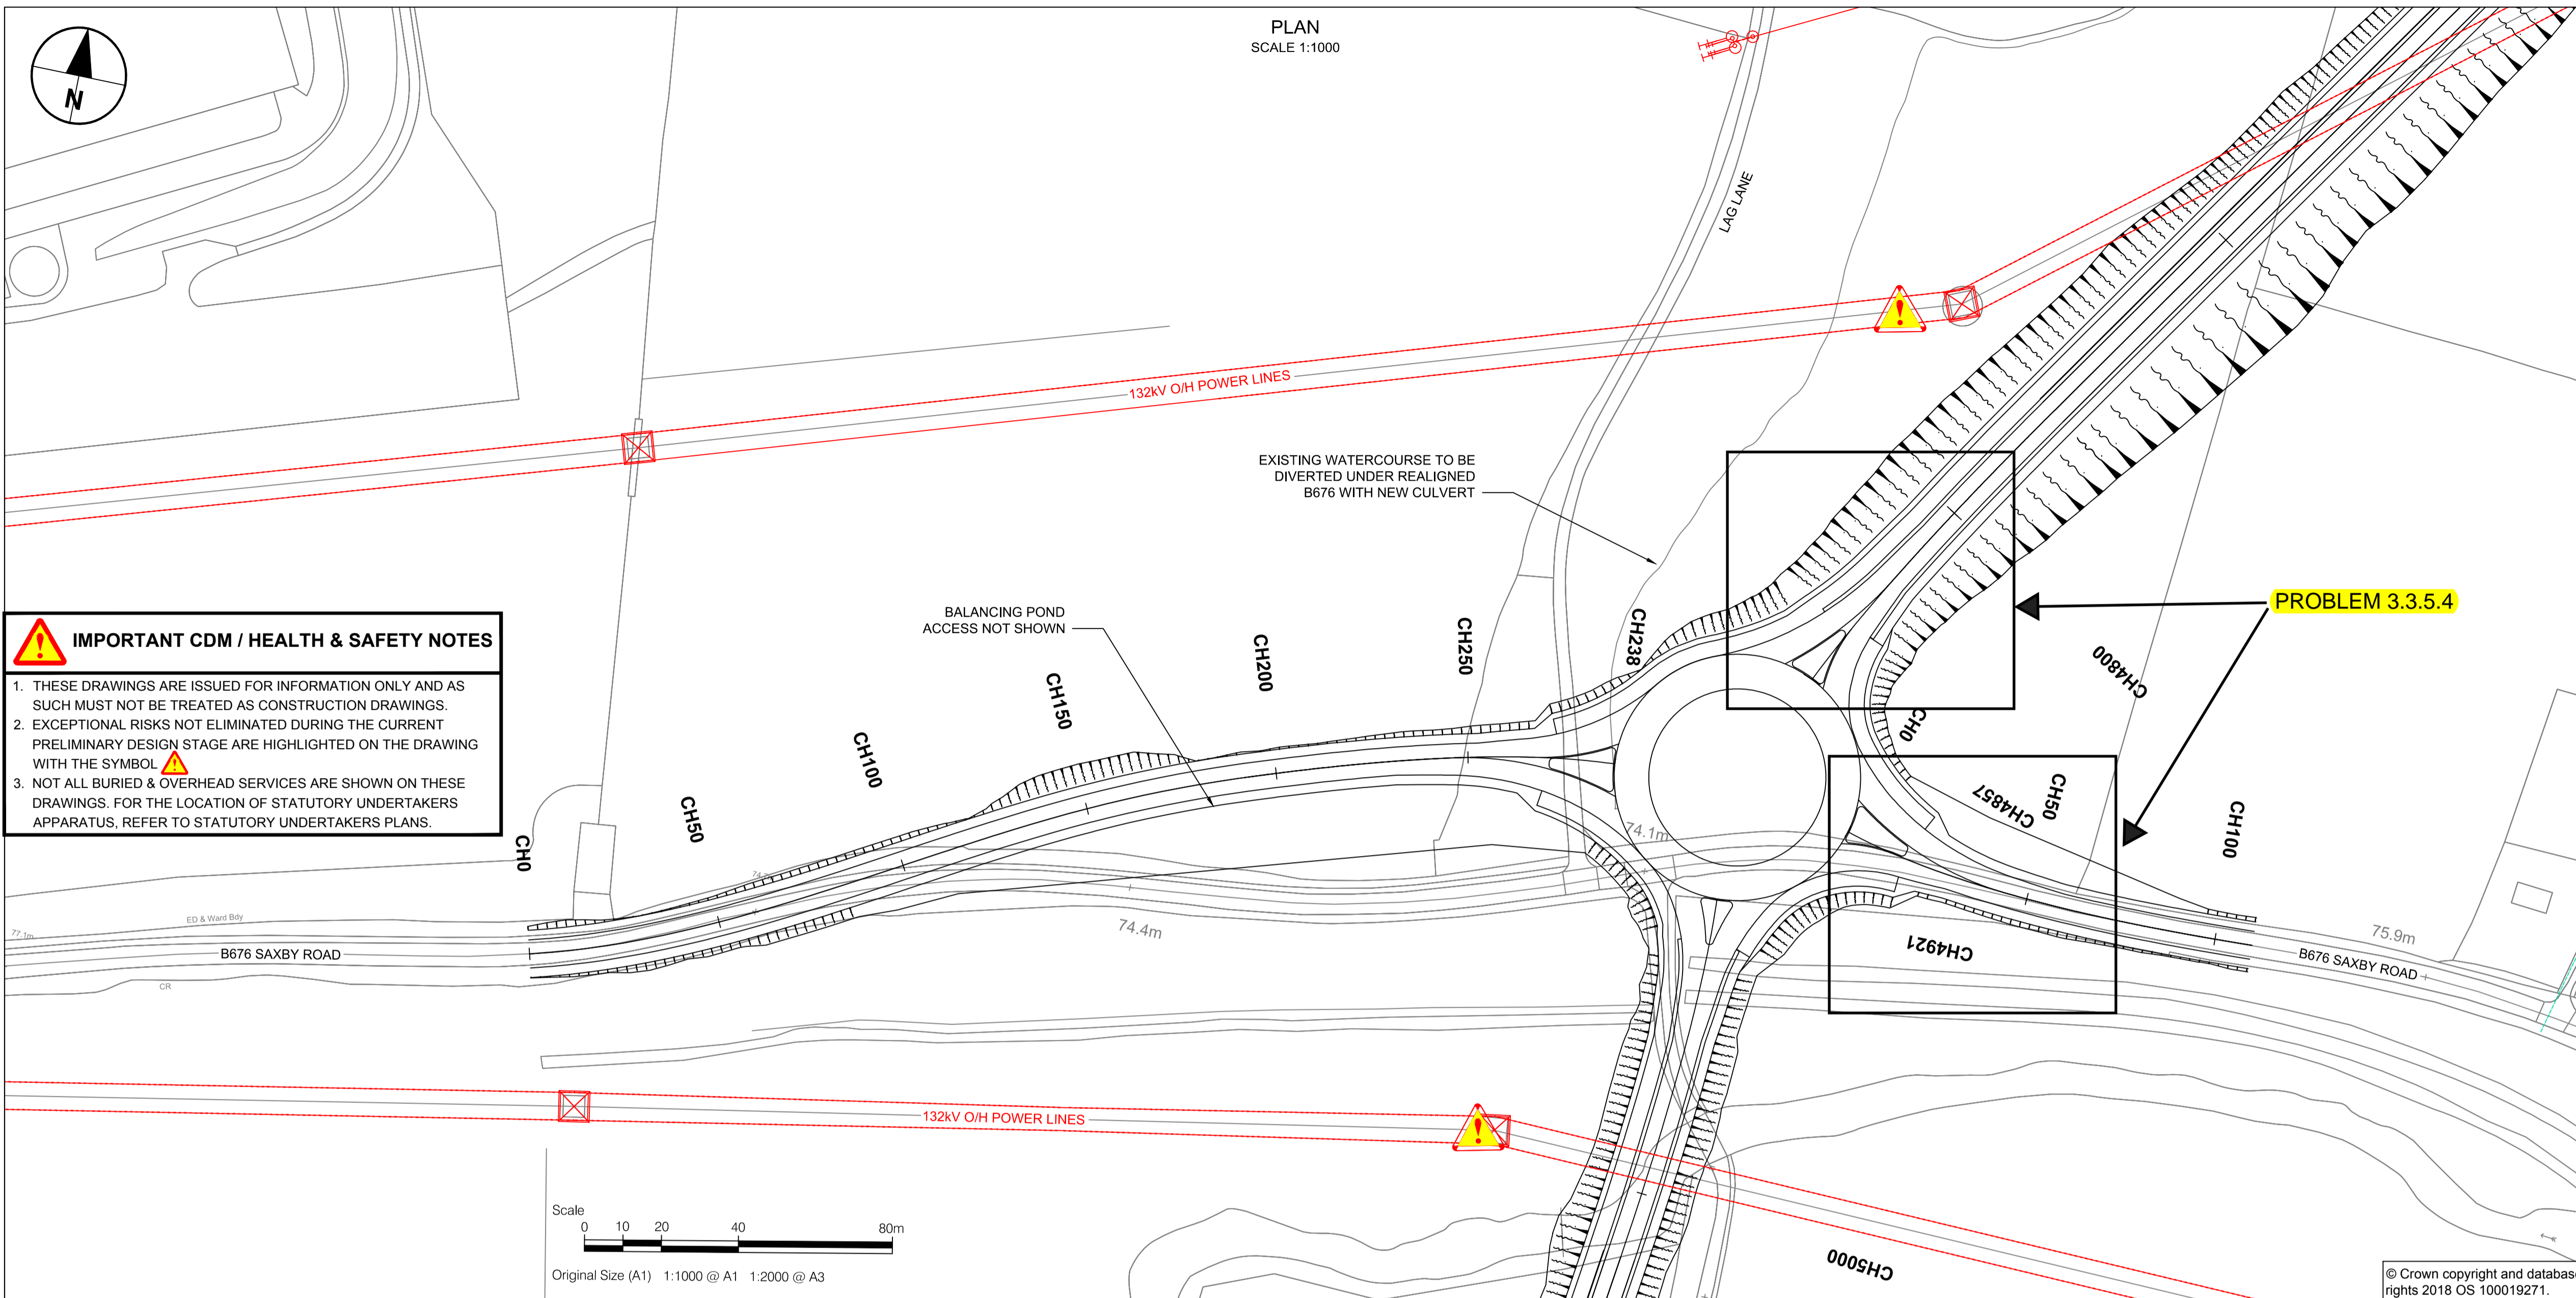
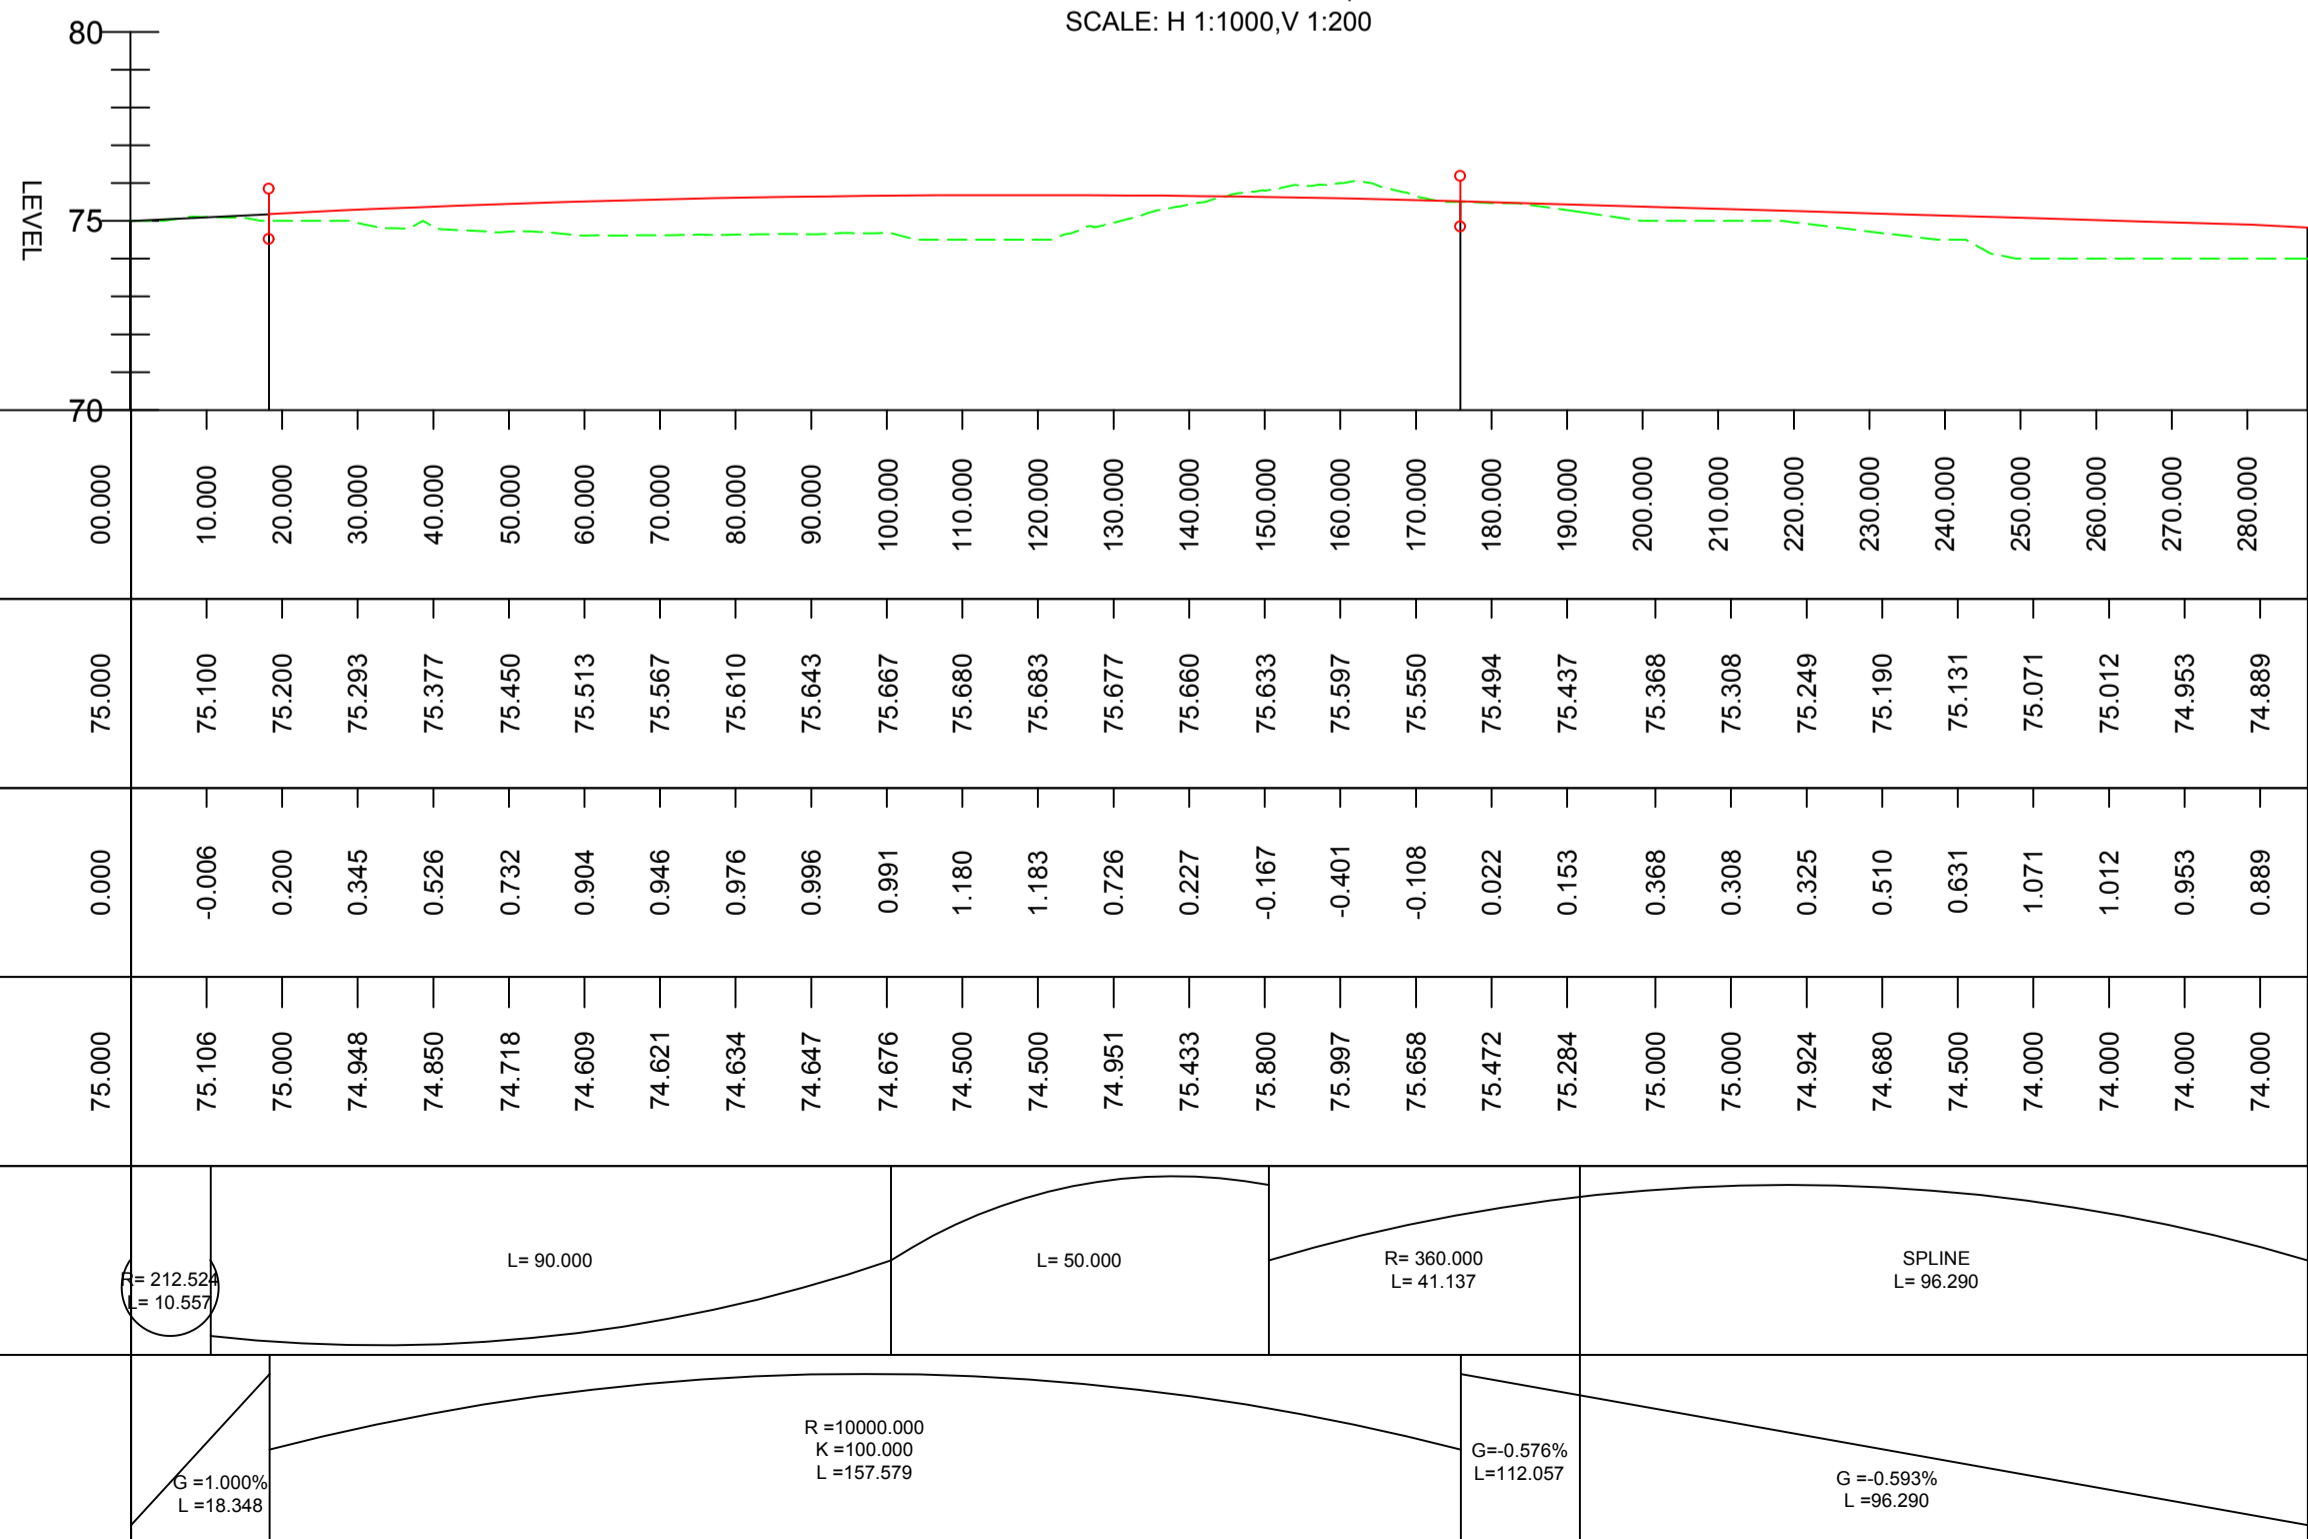
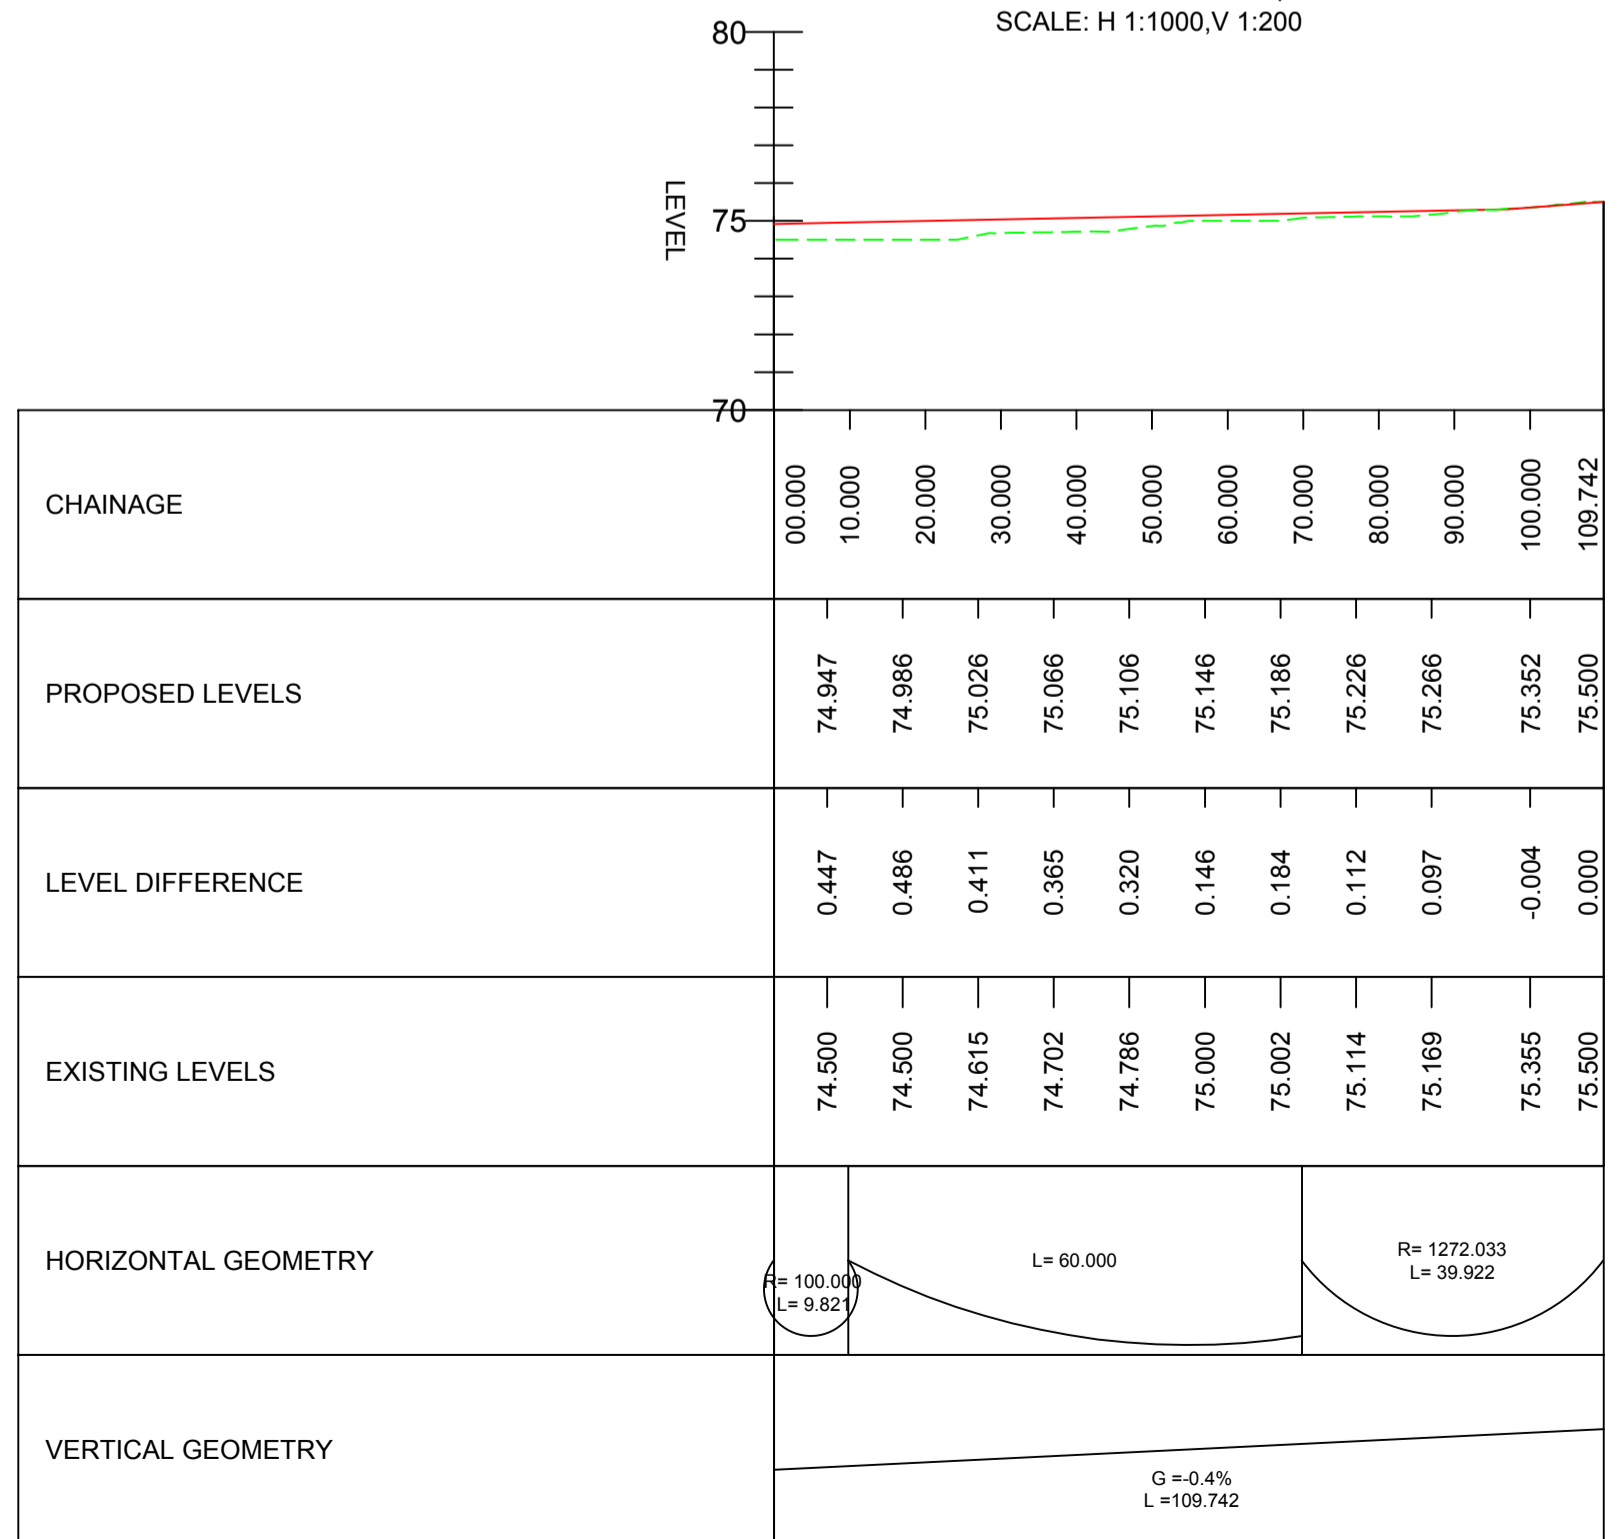
SHEET TITLE
SECTION 4 ROUNDABOUT 5
PLAN AND PROFILE

PROPOSED B676 WEST ARM PROFILE

DESIGN SPEED = 100kph
SCALE: H 1:1000, V 1:200

PROPOSED B676 EAST ARM PROFILE

It is recommended that the MMDR southbound approach and the B676 Saxby Road approach to roundabout 5 is reviewed to ensure sufficient deflection is attained to slow vehicles on the approach and travelling through the roundabout.
